NBSIR 84-2858 (R)

Report No. 11

Observations of the April 8, 1979 Railroad Accident at Crestview, Florida

U.S. DEPARTMENT OF COMMERCE
National Bureau of Standards
Center for Materials Science
Washington, DC 20234

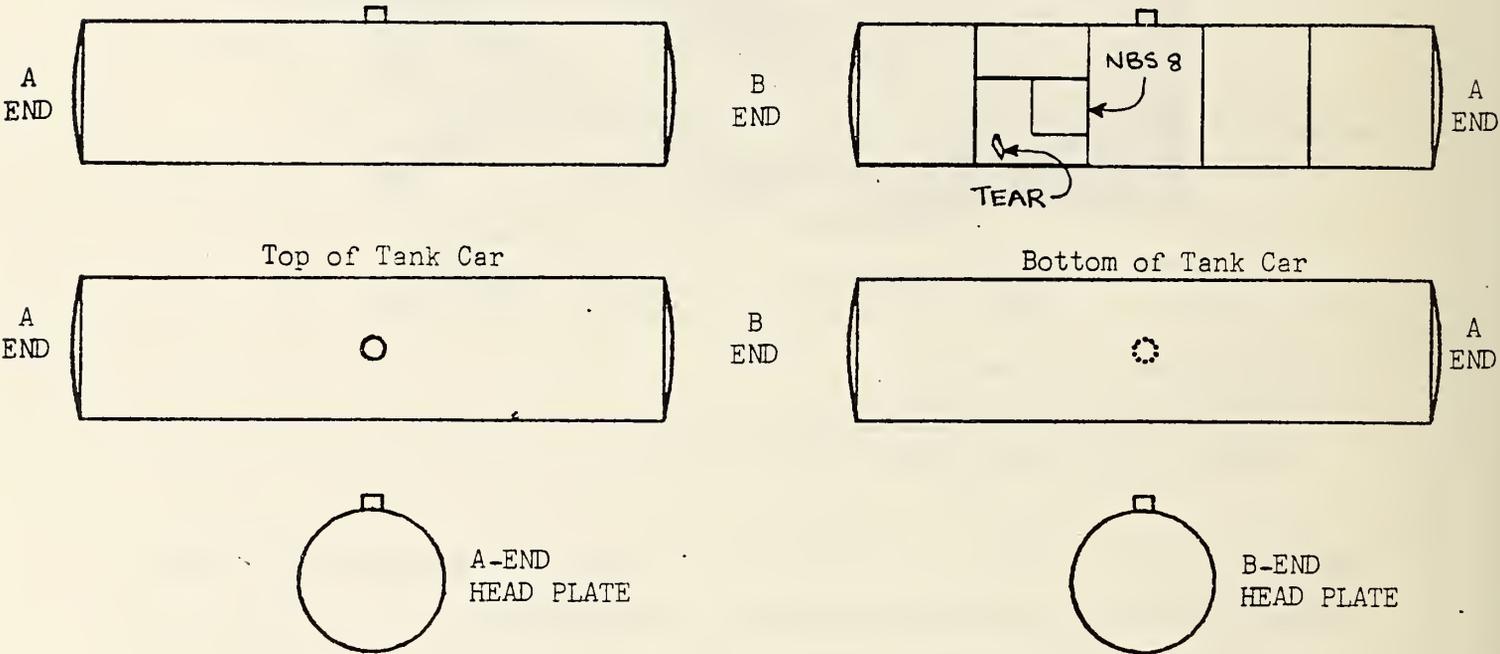
Shell and Head Plates: This very badly damaged car had only one fracture (in course 4). It was 17" long in a shell plate at a region of very high strain. NBS 8 contains course 4 and the weld to 3. The A-head contained a dent at the edge. (cont. on Attachment _____)

SAMPLE IDENTIFICATION NUMBER	OTHER SAMPLE IDENTIFICATION MARKINGS	LOCATION OF SAMPLE ON CAR
NBS 8		Shell course 4.

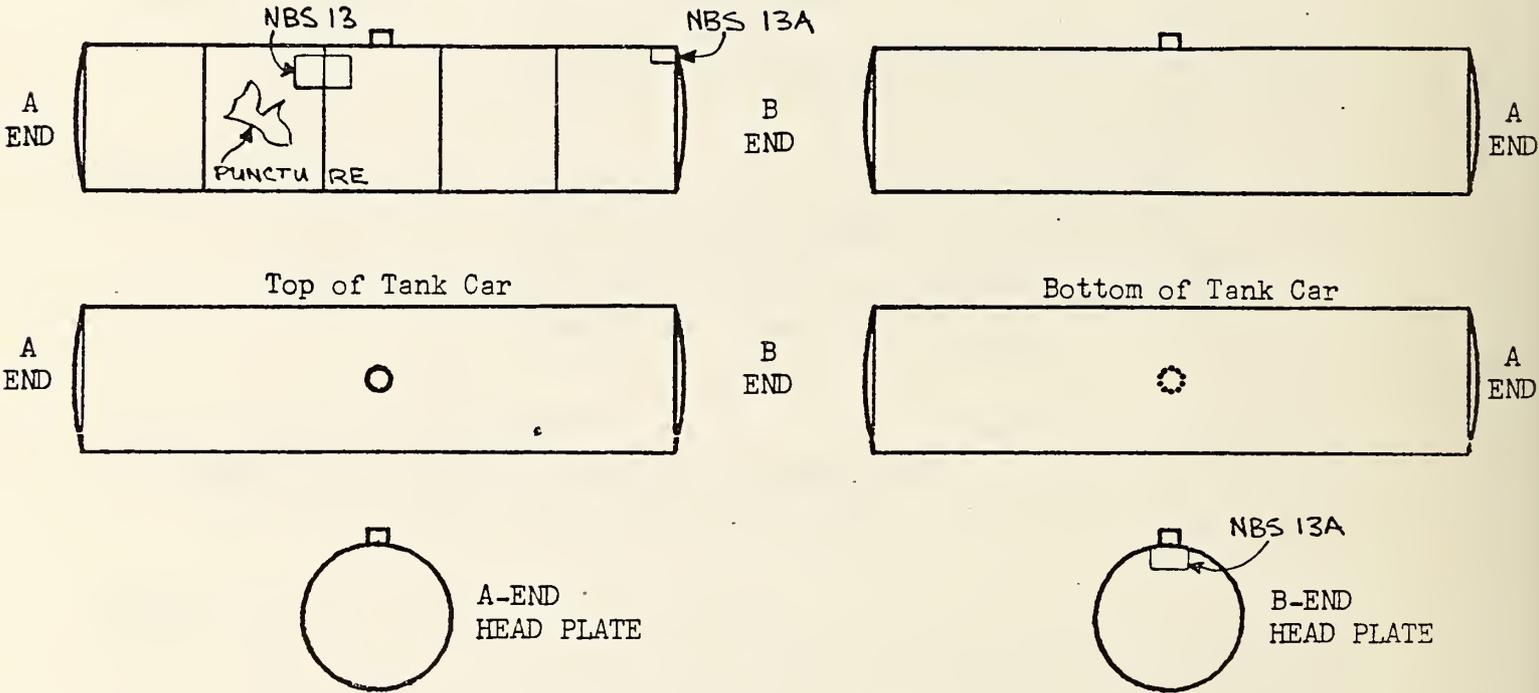
Shell and Head Plates: Car leaked its contents from fractures. Fractures were observed on top and on bottom where a 2-ft. long fracture (see 2-15) exists in the course that contains the relief (cont. on Attachment A)

valve (course 3). On top of 63" fracture is largest flaw.

The tank has a banana shape. The 63" rupture is generally lying in the girth weld direction away from the girth weld.

NBS 13 is located in two shell courses (one contains 63" rupture); NBS 13A is located in the severely dented head plate, but it is in a relatively undeformed part of this head plate.

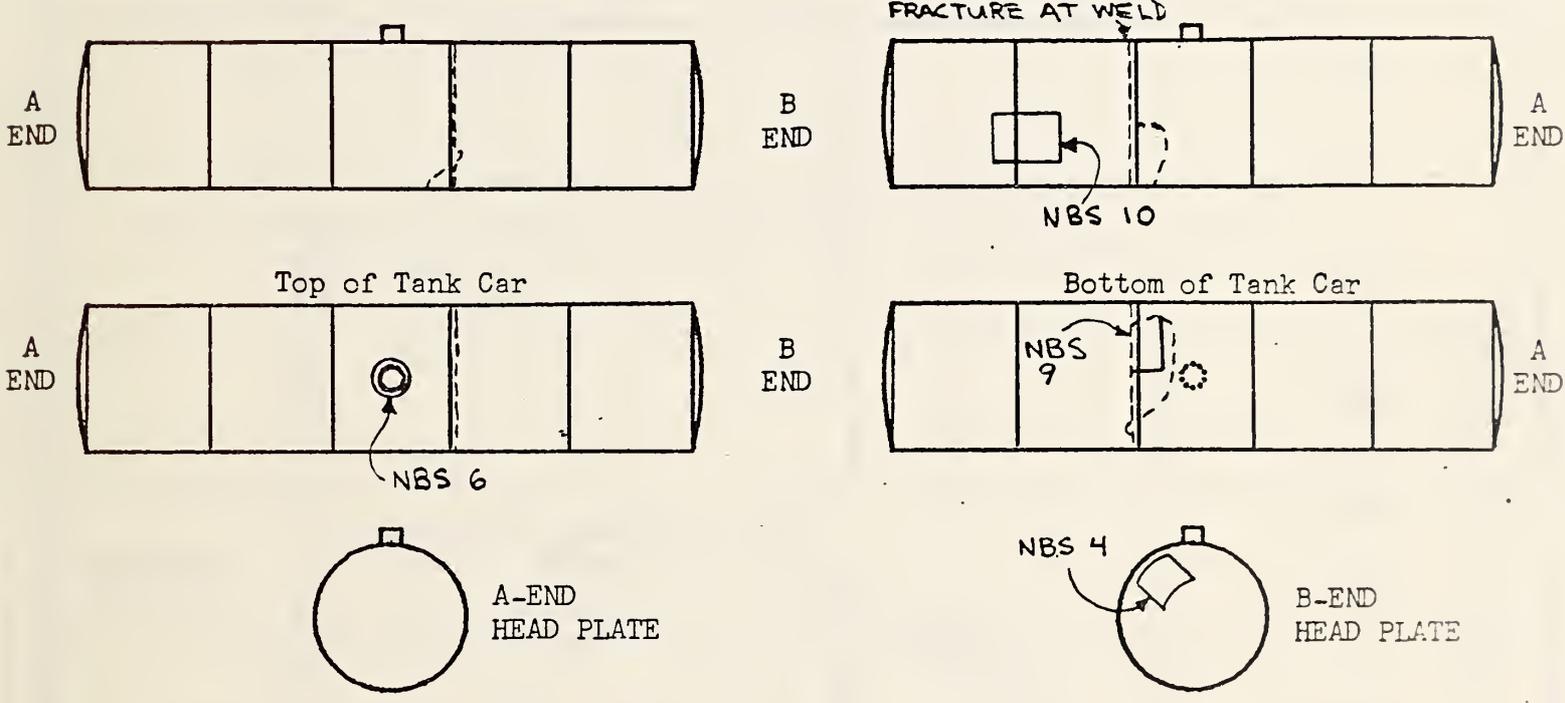
Shell and Head Plates: Failed circumferentially into two parts: one was badly flattened and contained NBS 6. The other contained NBS 4 on a badly damaged, but not fractured head, as (cont. on Attachment A)
Sill, Coupler, Wheel, other parts (in that order) _____

The tub containing the B-head was generally intact, although deformed so that it no longer is a cross-section of a cylinder. The B-head itself exhibited a massive dent at one edge, but no sign of rupture. The tub containing the A-head was severely flattened with numerous ruptures, along girth welds (between the head and shell plate and between shell plates).

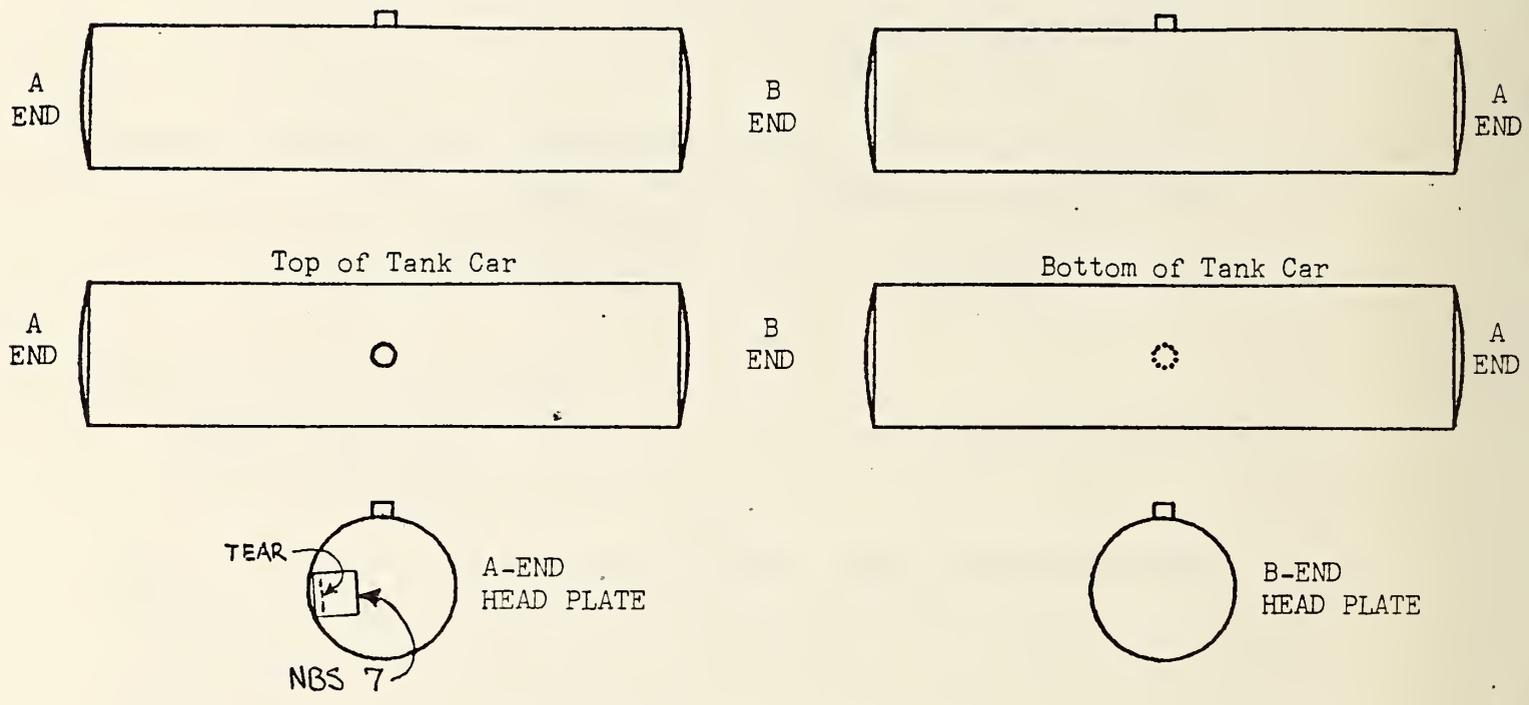
Shell and Head Plates: Badly damaged head plate that fractured (C3-5 photo) but did not run. Shell course (C2-13 photo) fractured but did not run. No significant damage observed on the (cont. on Attachment A)
Sill, Coupler, Wheel, other parts (in that order) _____

B-head. The A-head contained numerous dents, one of which contained a short rupture.

Substantial deformation of the shell courses was observed with one fracture along a girth weld between two shell courses.

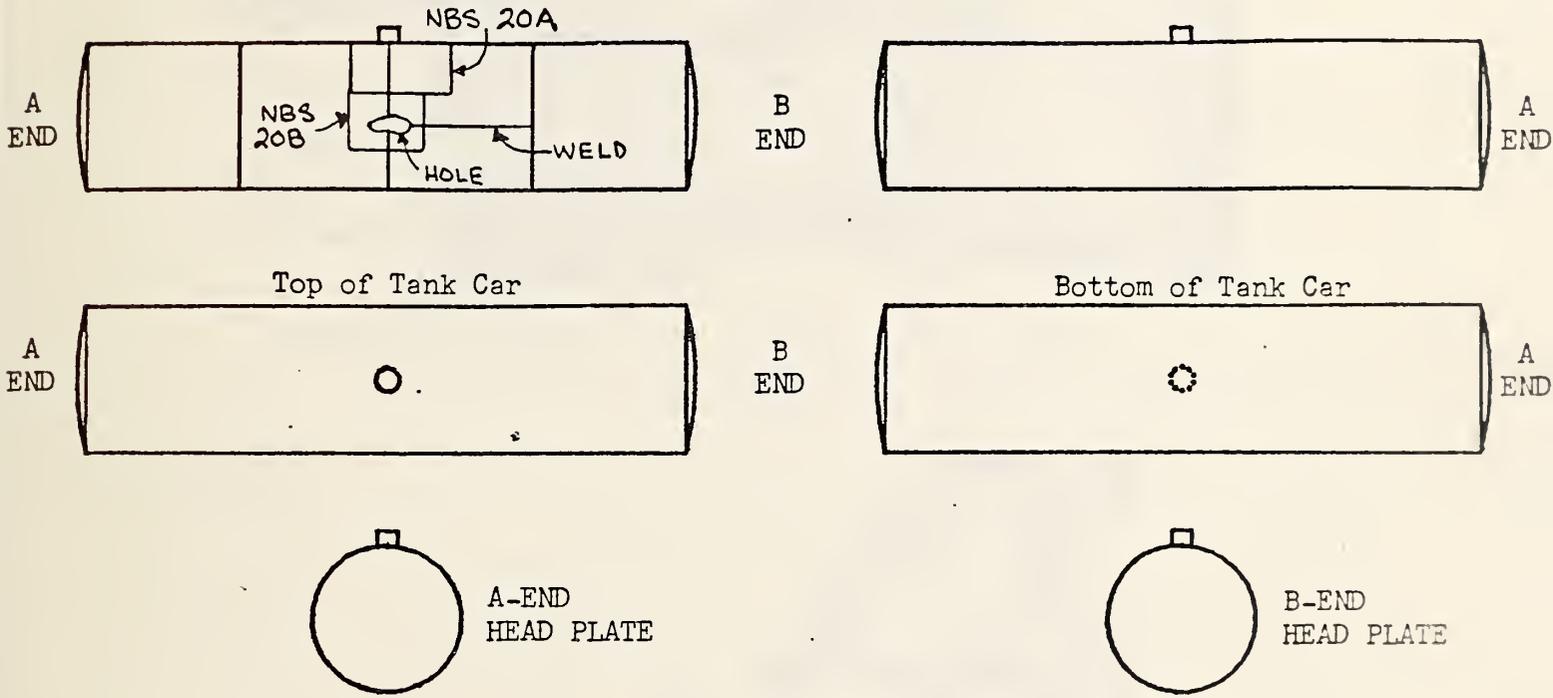
Shell and Head Plates: The leaking shell course had a hole punched in
it just below the middle of the shell course.

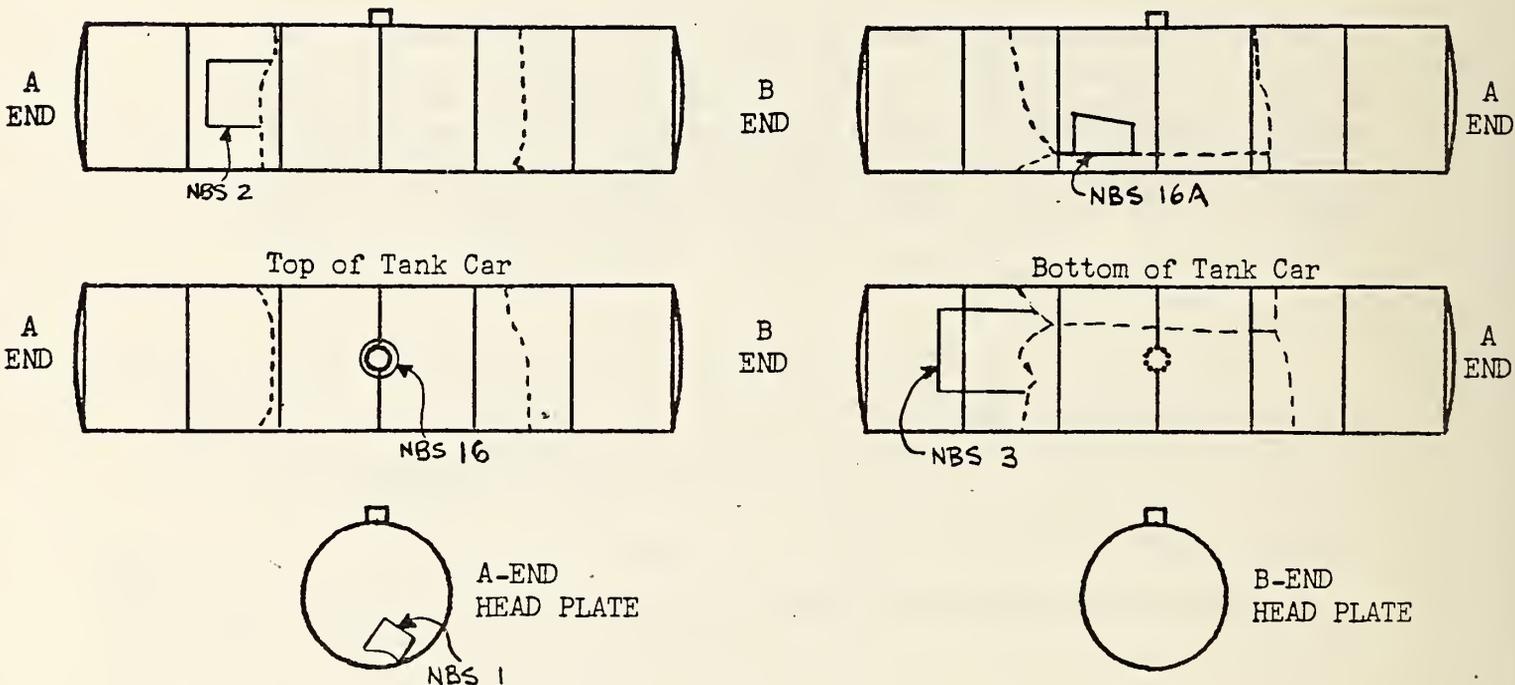
Rocketed tub, with 2-1/2 shell courses, was found on the south side of tracks. It had a badly dented head plate with no fractures. NBS 1 was taken on this head plate. The fracture line on this tub is contained in NBS 2.

North side tub, with 1-1/2 shell courses, is shown to be less affected by fire. See the photo 1-37 of this tub. The fracture face of this tub is shear everywhere except the part marked NBS 3.

The other 2⁺ courses were found on the south side of the tracks. The valve on it was marked NBS 16. See Notebook CGI Milligan, Fla., for a description of this piece of the car. Shear failure was observed almost everywhere along the failed edges of the plates. One location showed considerable plate thinning. In several locations, the shear fracture appearance indicated that plate centerline inclusion content is probably high.

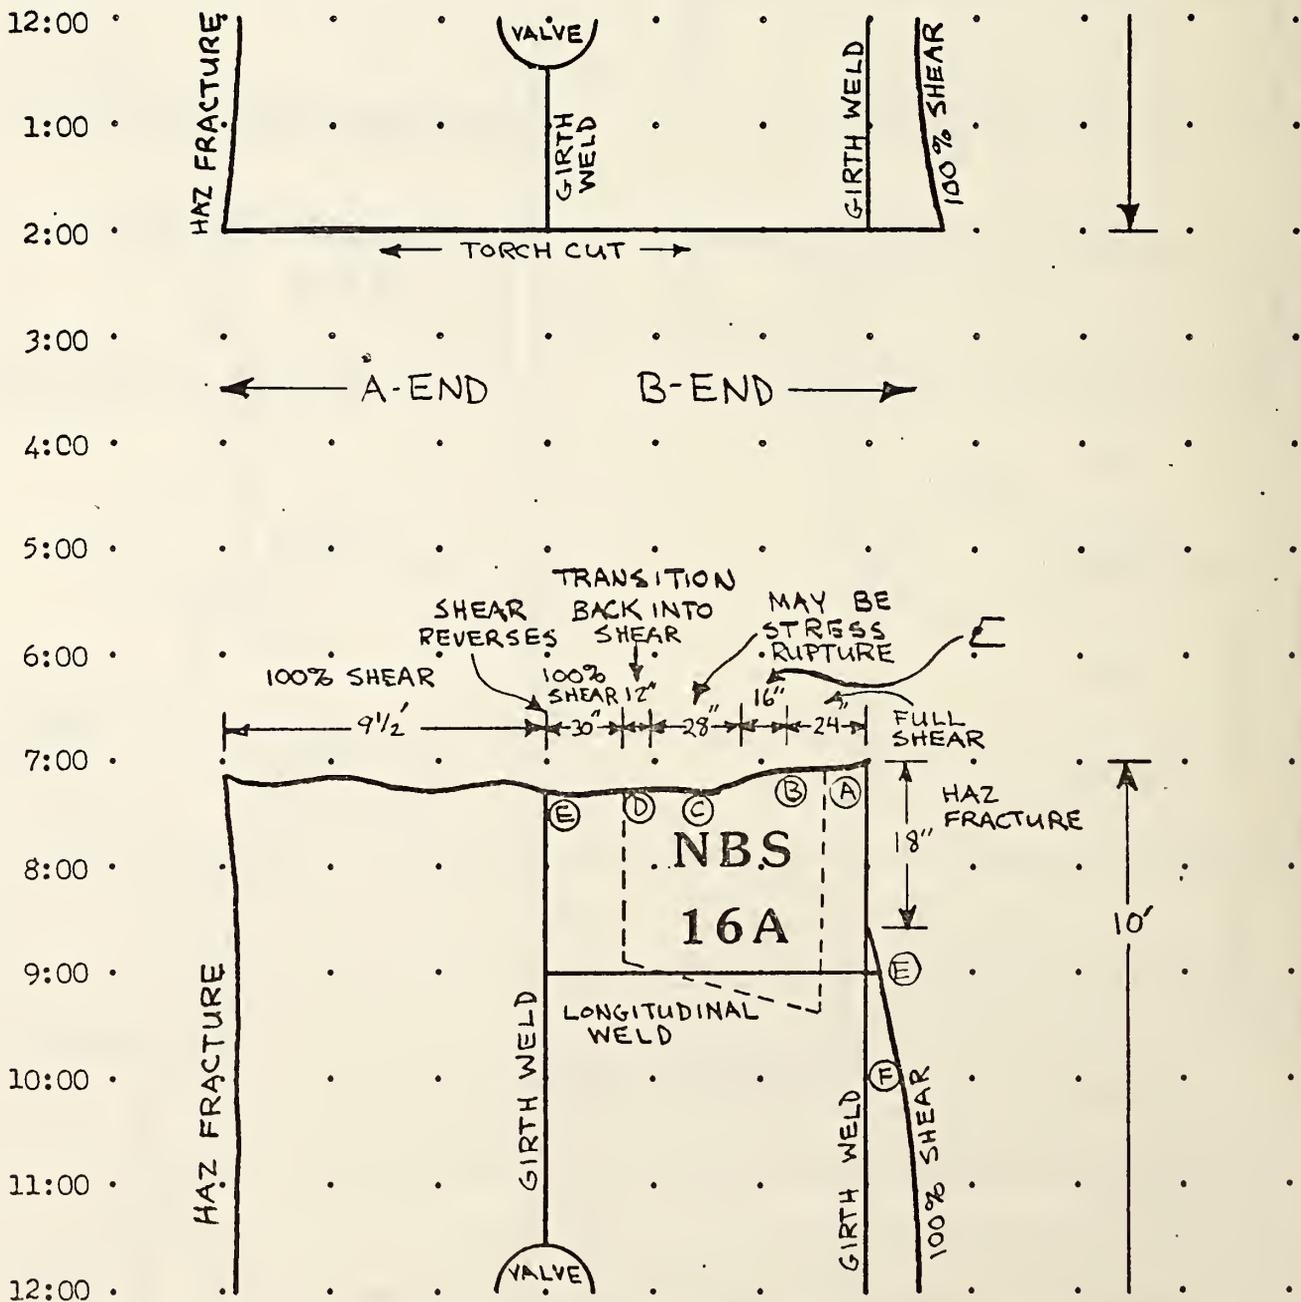
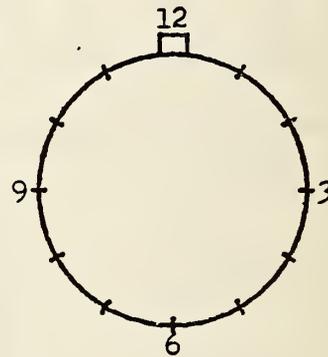
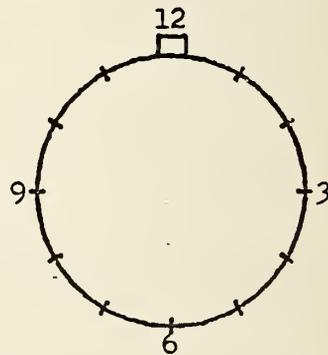
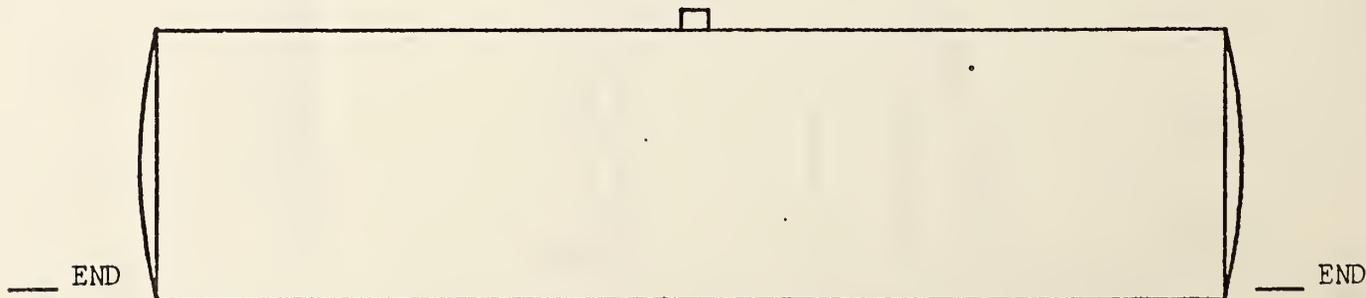
FRACTURE LOCATION (All time references are made for viewing from the A-End to the B-End of tank car.)	CROSS-SECTIONAL VIEW OF THE FRACTURE
A-end fracture 2:30 - 4:00 9:30 - 10:00	
A-end fracture 4:00 - 9:30 B-end fracture 12:00 - 3:00 & 6:00 - 7:00	DUCTILE
B-end fracture 7:00 - 10:30 3:00 - 5:00	lamellae
B-end fracture near 6:00	
B-end fracture 5:00 - 6:00	lamellae

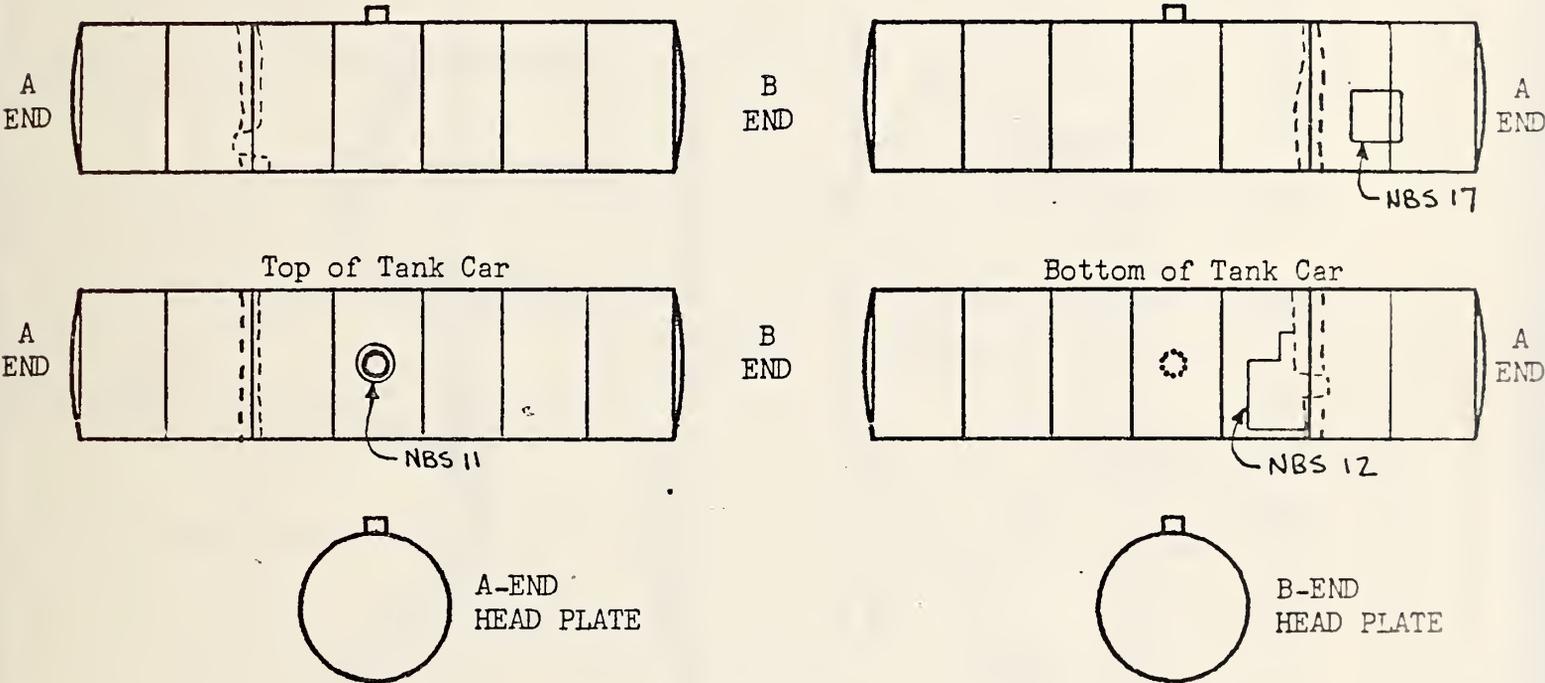
Shell and Head Plates: Rocketed and landed >1000 ft. south of tracks.
NBS 12 is sample on north side tube (see photo 2-8) A portion of the shell course (1-2 ft.) at the fracture is missing. (cont. on Attachment A)

and was not found during clean-up of accident site. Chevron marks were recorded on this, a largely brittle, fracture. See photo 2-8. Sample NBS 12 does not contain this characteristic fracture, except on NBS 12 extended.

NBS 17 is taken from the South side tub in the course containing the fracture, but the sample contains none of the fracture. This course is one shell removed from the head.

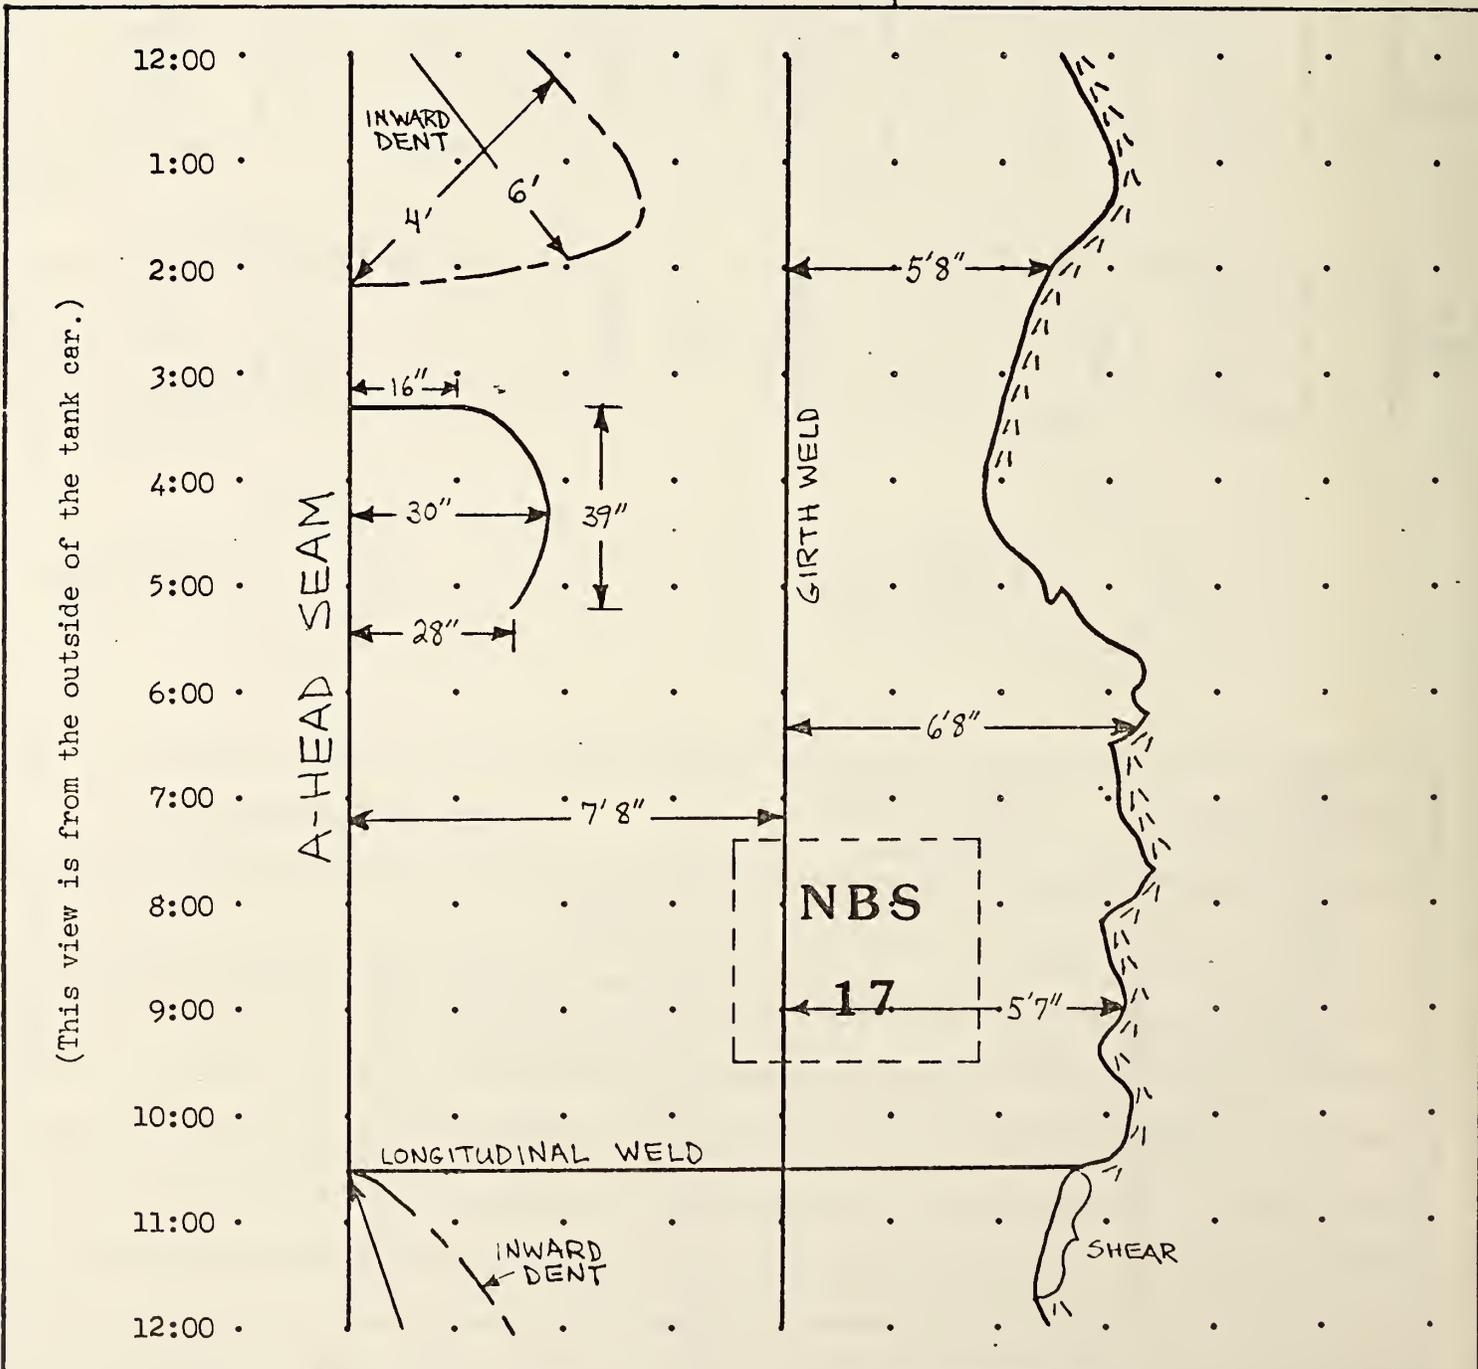
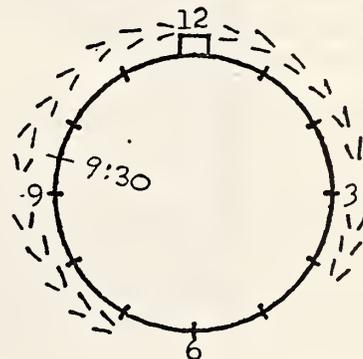
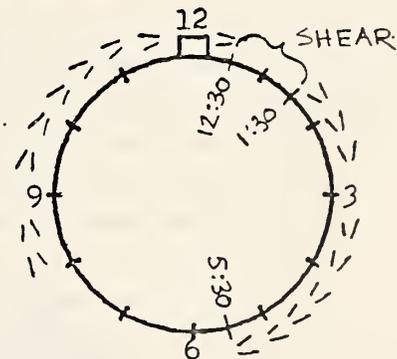
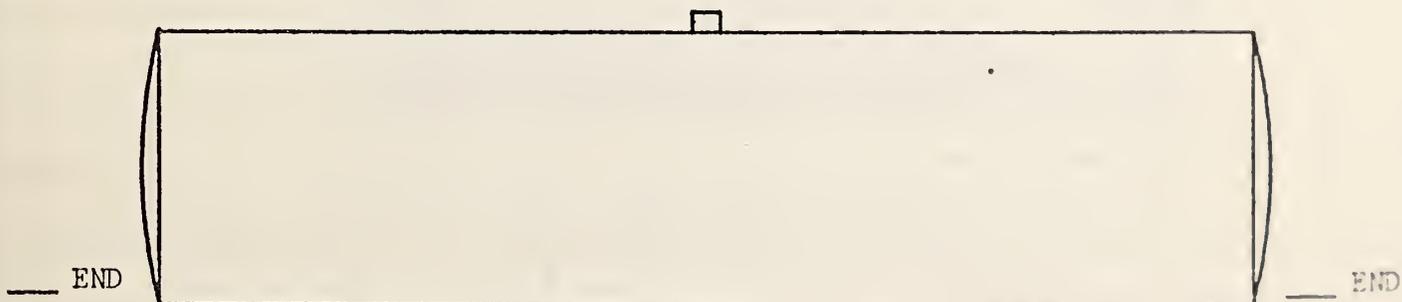
FRACTURE LOCATION (All time references are made for viewing from the A-End to the B-End of tank car.)	CROSS-SECTIONIAL VIEW OF THE FRACTURE
Fracture on B-end 7:00 - 9:30

Brittle
Fracture on B-end 9:30 - 4:00

Brittle
Fracture on A-end 12:30 - 1:30

Ductile
Fracture on A-end 8:00 - 12:30 1:30 - 5:30

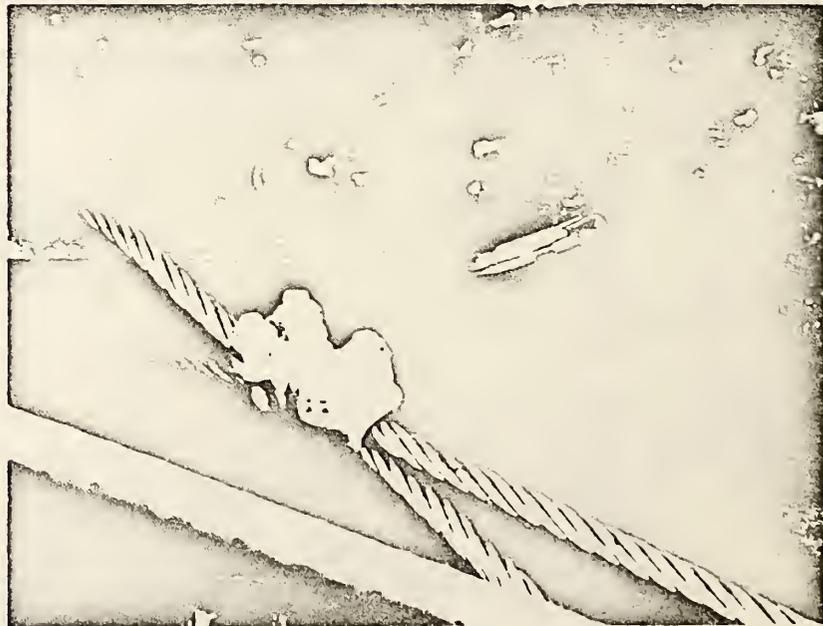
Photo C4-3: Close-up of the probable fracture origin
of the north side tub (B-end) of tank-
car ICX 2827.
